CONCRETE RETAINING BLOCK WALLS

Project Review - Hydraulic Applications

CONCRETE RETAINING BLOCK WALLS IN HYDRAULIC APPLICATIONS

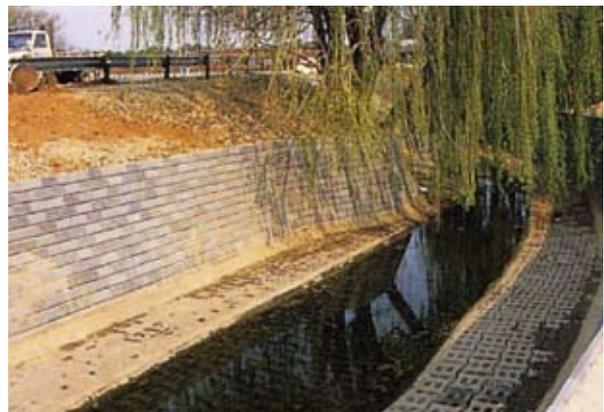
Photograph 1 Stream embankment - Randburg

Continued erosion of a stream embankment in Randburg posed a serious threat to buried municipal services. An Enviro-Wall earth retaining structure was chosen and installed to protect these services and allow the stream to meander along a defined water course, thus maintaining existing vegetation.

The stream bed was further protected by lining it with an Armorflex erosion protection system.

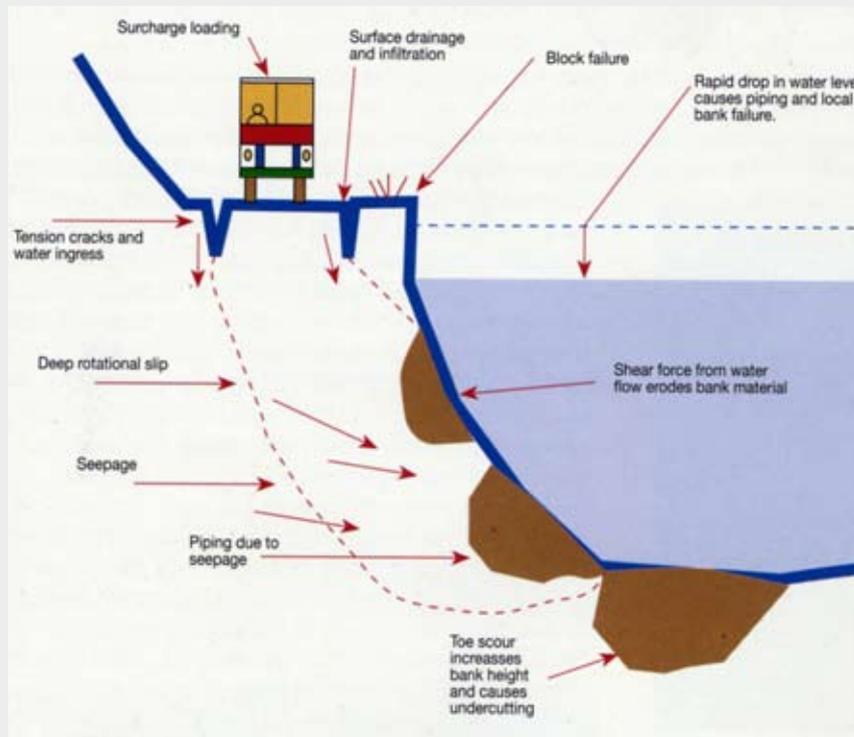
Figure 1: Erosion forces on channel bank. Apart from the erosion by current flow, erosion can be generated by the following factors:

- Wave action: boat or wind driven waves wash against bank causing removal of material.
- Seepage: groundwater flow, depending on hydraulic gradient and permeability, causes piping, and uplift from pore water pressure.
- Surface run-off: this causes gullying and removal of bank supporting vegetation.
- Effects of local features: large rocks in stream bed or hydraulic structures can drive the flow against a bank increasing the shear force on the bank.
- Desiccation: wetting and drying in clays can cause deep cracking, weakening the soil and leading to block failure.
- Animal and man: traffic along the bank destroys soil retaining vegetation while burrowing animals can destabilise the bank.
- Sudden water level fluctuation: rapid rise in water level causes uplift forces on the bank, while rapid drawdown causes temporary high pore pressure in the bank which can lead to minor block failure.

Erosion occurs when erosive forces exceed the resistive forces of the bank. This initial erosion often destabilises a section of bank leading to mass failure. The main processes responsible for erosion are illustrated in figure 1.

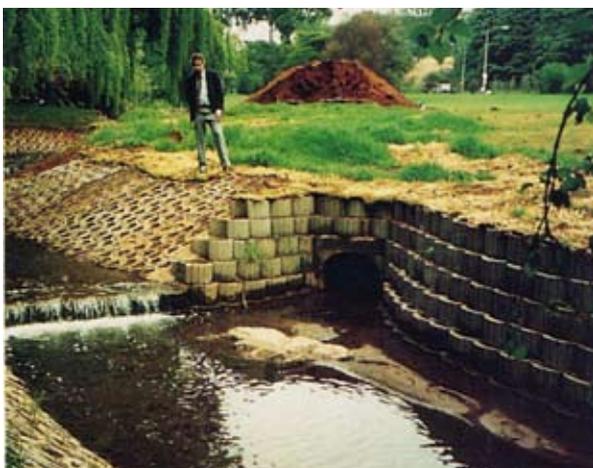
Photograph 2 River bank protection - Johannesburg Botanical Gardens

A tributary of the Braamfontein Spruit runs through the Johannesburg Botanical Gardens into the Emma-rentia Dam. At the top end of the Botanical Gardens the stream was suffering considerable erosion and flooding damage. It was therefore necessary to line the stream and improve its geometry to eliminate erosion and limit flooding.

The area is extremely environmentally sensitive and the decision was made to use Terraforce and Terrafix blocks because of their plantability. Although unproved in rapidly flowing rivers, this project was to serve as an experiment to test these products under fast flowing water (8m/s). The banks around the bends were protected with Terraforce blocks while straight sections were lined with Terrafix on 1:3 slope to allow access to and through the stream. Longitudinally, the stream was stepped at 10m intervals to reduce the grade and hence velocities. The blocks were fixed into concrete cross beams at 5m centres. These beams were anchored to the stream bed with duckbill anchors to prevent uplift and roll up. The top two rows of Terrafix were filled with no fines concrete to give a rigid lip to allow the stream to overflow its banks in large storms. A typical cross section of the stream is shown in figure 2 over the page

Continuous monitoring of the stream lining during the 1993/94 rainy season revealed that apart from a few problems related to construction errors, the lining performed very well. The rainy season in question included numerous medium and a number of large storms where the stream overflowed its banks. The blocks were easy to plant and substantial growth took place very soon after construction. Critical details for blocks when used in streams and rivers are the

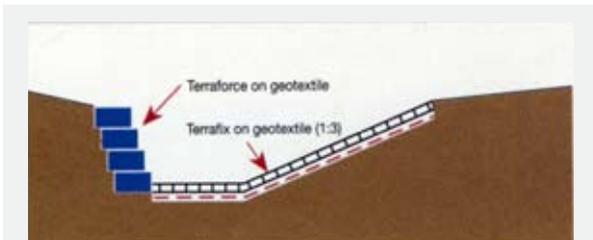
Figure 2a: Typical cross section at bends

shear keys between blocks. Extensive use of geotextiles, both to reinforce the fill embankment as well as prevent piping from the embankment is also critical. The backfill behind the blocks must be on a free draining nature to prevent build up of hydrostatic pressure. Vegetation of the blocks with deep rooting evergreen plants as soon as possible is critical to the success.

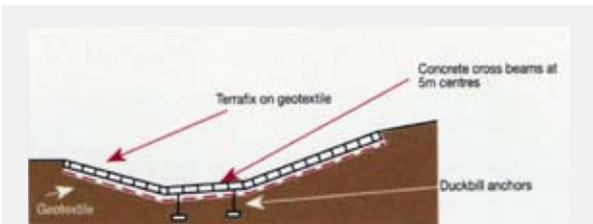
Figure 2b: Typical cross section on straights

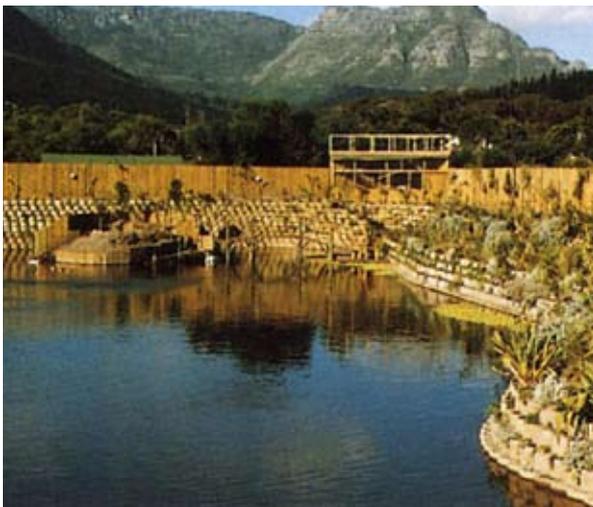
Photograph 3 Artificial Lake - House Ruben - Hout Bay

Concrete retaining blocks have also been used to construct artificial lakes; in this case at House Ruben, Hout Bay.

Terraforce was chosen for this project. The closed vertical surface structure combined with open horizontal structure of this system is permeable and does not inhibit the penetration of primary root systems. Furthermore, the system is interlocking both vertically as well as horizontally and offers maximum mass per square metre when completed.

After excavation, a gravel foundation was placed on a geotextile separation layer. Terraforce was constructed directly on to this foundation and filled with a mixture of gravel and soil up to the high water mark. Topsoil was used to fill the elements above this level. A geotextile filter layer was placed behind the blocks. Due to the flexible nature of the system, no settlement problems were encountered.

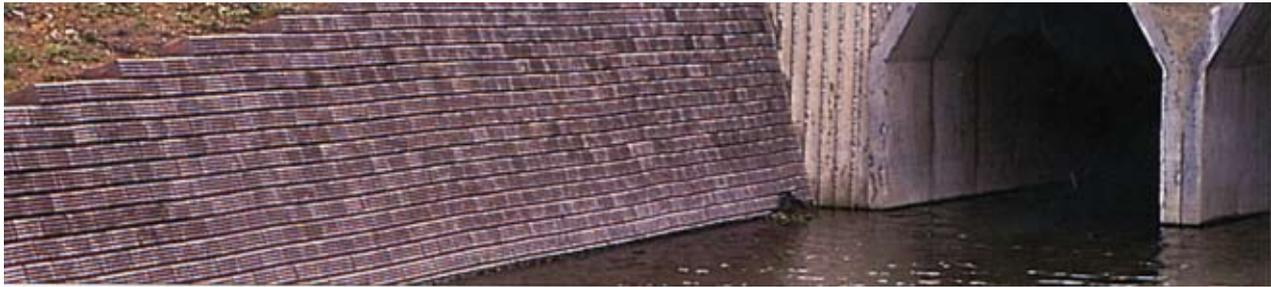
Photograph 4 River bank protection - Secunda

Due to its interlocking action, Enviro-Wall blocks were chosen to protect a river embankment in Secunda.

In the closed configuration, the blocks provide a hydraulically smooth section doubling in this instance as culvert headwalls.

Greening of Enviro-Walls in hydraulic applications is easily achieved by simply opening the blocks above top-water level to provide growth pockets.

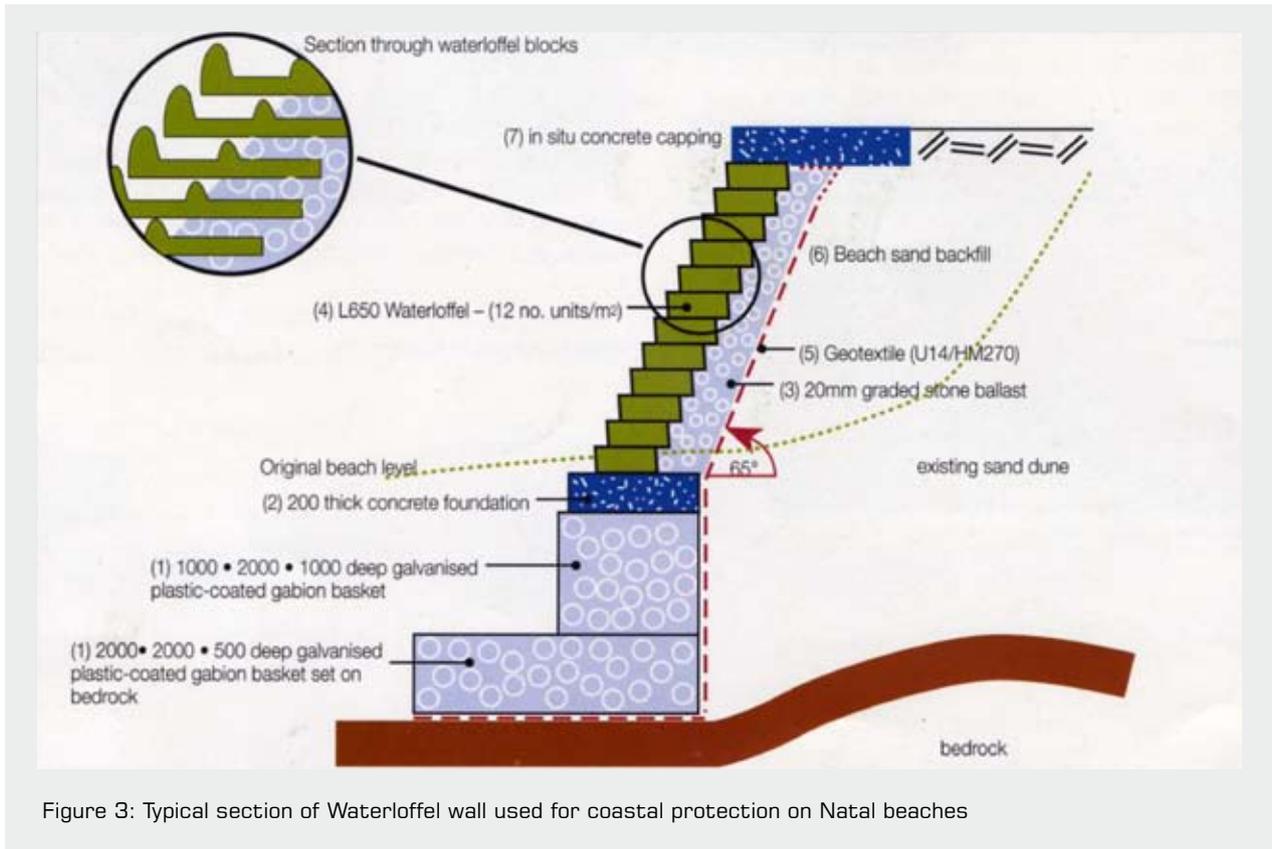
Figure 3: Typical section of Waterloffel wall used for coastal protection on Natal beaches

Research was carried out at Stellenbosch University where models were built to test the effect of wave action on the crb walls. As a result of this research, a method of construction was specifically developed for coastal protection. The method of construction is shown in figure 3 and includes the following:

(1) Galvanised plastic coated Gabion Baskets

(Packed with mass handstone): The baskets are used to form a firm footing on the bedrock wall below the lowest mean sea level. They also fulfil the vital functions of mass drainage due to the ground water and overtopping in times of heavy seas and a levelling medium on which to ground the walls concrete foundation.

This concrete foundation typically consists of 25 MPa strength concrete, 200 mm thick shuttered to a width of 900 mm. Waterloffel blocks are then placed on the wet concrete and set for line and level.

(3) Ballast drain: 20 mm Graded stone ballast drain must be formed from the centre compartment of the Waterloffel extending upward to 300 mm behind the walls and encapsulated in geo-fabric. This ballast is essential to allow free drainage behind the wall, especially when the wall is being overtopped by heavy seas.

(4) Waterloffel (Block weight 72 kg and 12 blocks per m²): After placing in the wet concrete of the foundation, the Waterloffel block is packed with its unique wings interlocked. The length of each wing governing the actual spacing between each block when packed tightly together.

(5) Geotextile: The geofabric is placed starting at the bottom of the first Gabion basket and extending upwards across the back of the Gabions and following the line of the waterloffel blocks, to the in situ concrete capping on the top of the wall where it is locked in between the last two blocks. The geo - textile is very important, firstly as a barrier allowing free flow of water, while restricting the fines and the secondly, providing vertical stability and lateral strength through the back of the wall.

(6) Backfill: The void between the toe of the dune and the top of the wall behind the waterloffel construction should be filled with clean, coarse, free drain sea sand which is normally taken from the low tide mark.

(7) In situ concrete capping/ledge beam: It is essential that a concrete capping be used on top of the wall, firstly for stability, in that acting with the foundation concrete, it provides the framework, locking the entire construction together and secondly, in the event of overtopping, the ground water returning over the top of the wall is unable to erode the soil behind the blocks which might failure of the wall. The in situ concrete edge beam also provides a handy means of fixing uprights for a balustrade should one be required.

Capping	20 MPa concrete - Laid in panels 200 mm thick and 1.5m wide with expansion joints every 4.5m
Edge beam	20 MPa concrete - 300 mm thick and 700 mm wide

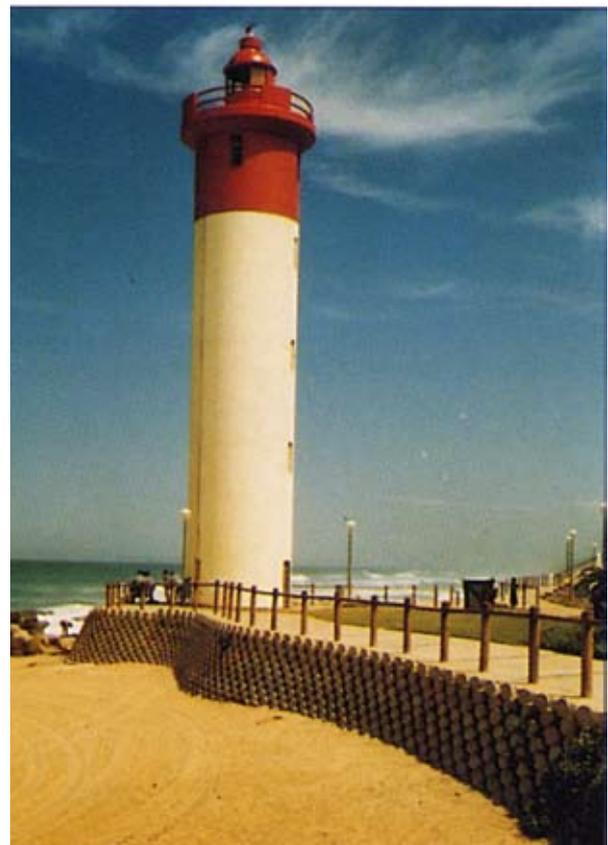
Photograph 5 Concrete retaining wall - Umhlanga Rocks

A foundation for the wall was constructed using large (1m x 5m x 2m) Gabions founded on the bed rock. Once the Gabions were in place, concrete was cast on the Gabions to form a foundation for the Waterloffel blocks.

The new wall was built to a height of 4m from the bed rock and forms the foundation of the beach walk. (See photograph 4)

To make the wall more attractive, indigenous dune vegetation was planted in sandfilled blocks.

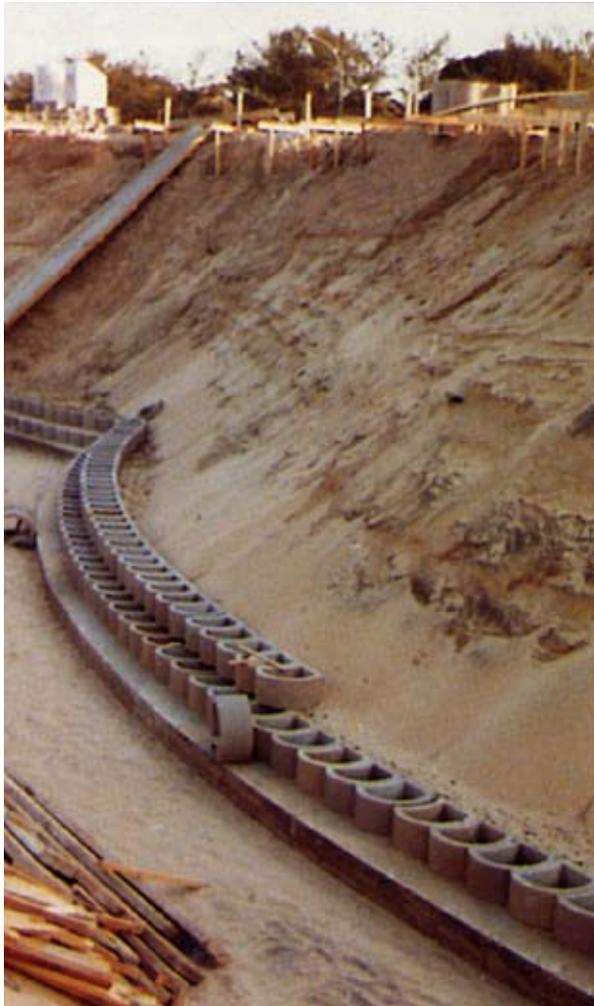
Photograph 6 Laguna Beach - Under construction

After excavating the beach to a foundation level of 1.5m below m.s.l., (also the level of water table), a 1100x250 mm foundation of 25 MPa concrete was cast.

The bottom 3 m of this structure, which is normally situated below beach level, was constructed with Terraforce elements filled with 15 MPa concrete and hot dip galvanised dowels locking individual rows together. Selected coarse backfill and weepholes were provided.

As a front line of defence in case of severe erosion of the beach, a Gabion mattress apron topped with sand (4% cement — 1,5 m wide and 1,5 m high) was placed on top of the concrete foundation. The contractor then constructed the wall to its full height of 6m above foundation level with the units filled with plant supportive topsoil. The structure is curved to match the radii of paddling pools above, and an existing stormwater outfall was incorporated to form a functional, yet attractive spillway onto the beach.

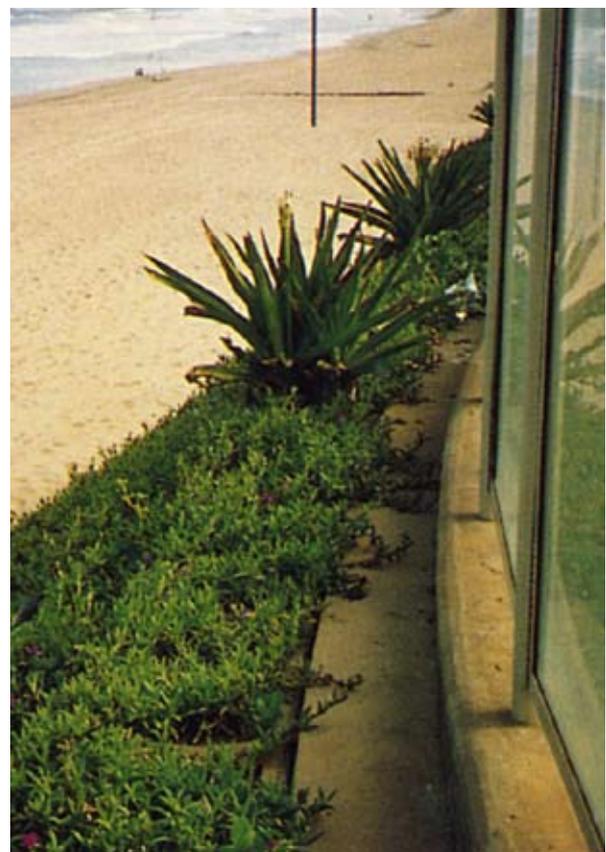
Photograph 7 Laguna Beach - After vegetation

The structure is fully covered with indigenous vegetation and has experienced many severe storms in the past eight years without any evident damage (see photograph 7).

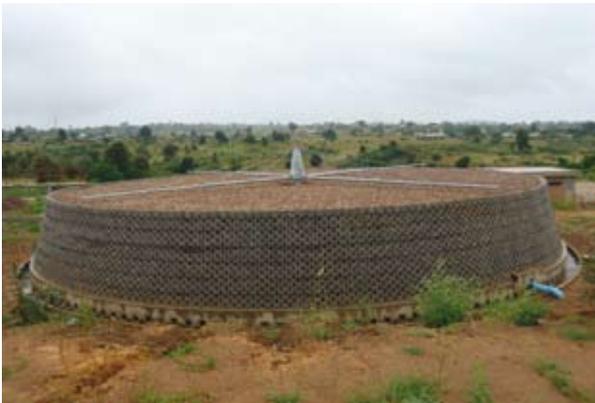
BIOFILTERS

Biofilters: Sewerage effluent water treatment tanks have utilised concrete retaining block walls to retain the ballast stone infill. The voids between the blocks allow air to ventilate more efficiently, the block walls with geogrid reinforcing placed 4m deep into the ballast, limit movement caused by temperature induced settlement of the ballast stone, giving tanks a longer life.
